# Manhole Inspection Summary

Manhole # S09WW\_006MH

Insp Date: **2/23/08 2:06 PM**

**Location** Address: **3323 LIBERTY HEIGHTS AVE**

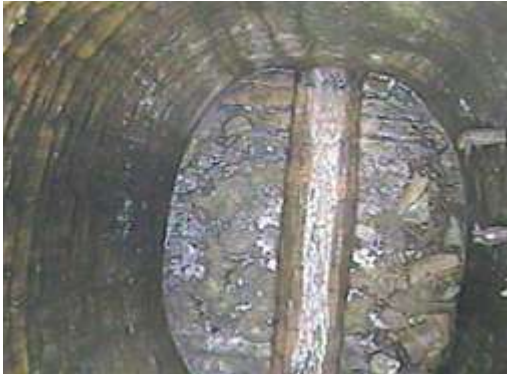
Top View

Offset: **3** (in.)

frame offset

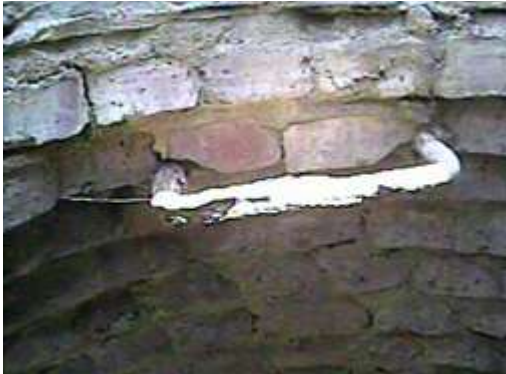
Defect 1

Count: **3** Missing: **2** ☒ **Corroded**

CORRODED STEPS

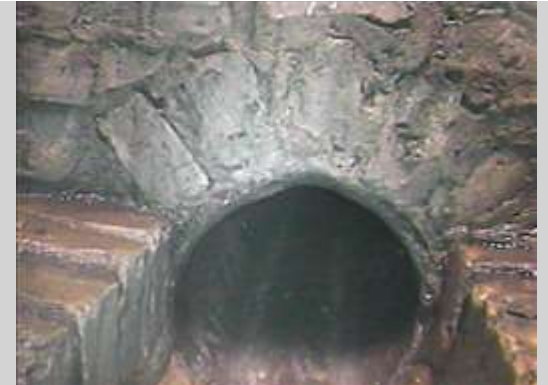
12 O'Clock Outflow

8 in. Circular Gravity Sewer  
Pipe Out @ 12 O'Clock

Pipe Height: (in.) Direct  
Pipe Material: **Clay** ☐ Pipe Lined  
Invert Depth: **6.94** (ft.) Flow Characteristics: **Fast**  
Deposits: ☒ None ☐ Mud ☐ Sludge ☐ Debris ☐ Grease  
Silt Depth: (in.) Deposits Extent:  
Infiltration: **None** Pipe Seal Cond: **Sound**

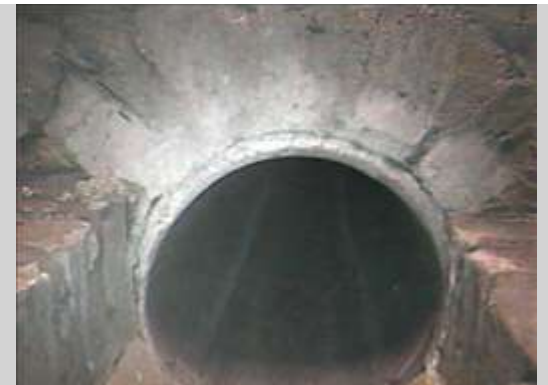
6 O'Clock Inflow

8 in. Circular Gravity Sewer  
Pipe In @ 6 O'Clock

Pipe Height: (in.) Direct  
Pipe Material: **Clay** ☐ Pipe Lined  
Invert Depth: **6.85** (ft.) Flow Characteristics: **Fast**  
Deposits: ☒ None ☐ Mud ☐ Sludge ☐ Debris ☐ Grease  
Silt Depth: (in.) Deposits Extent:  
Infiltration: **None** Pipe Seal Cond: **Sound**
